Inspection Report

Property Address:
1234 Somewere St.
Myrtle Beach SC 29588

CHI: Cornerstone Home Inspections of SC, LLC

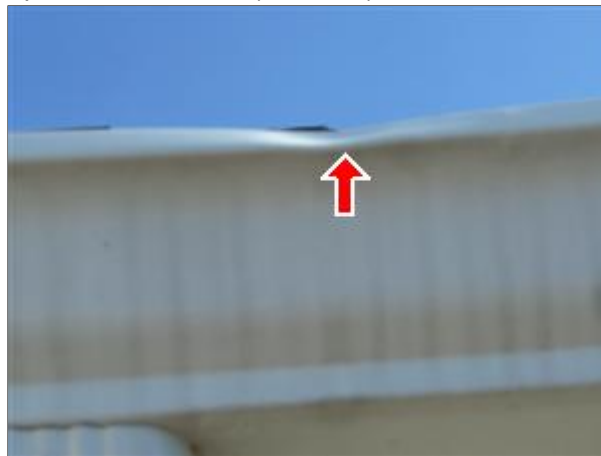
1.4 Picture 1 Left side gutter

Comments:
 One small dent in the gutter on the left side of the screened in porch, this purely cosmetic and does not impede the structure or the operation of the unit.(Picture 1)

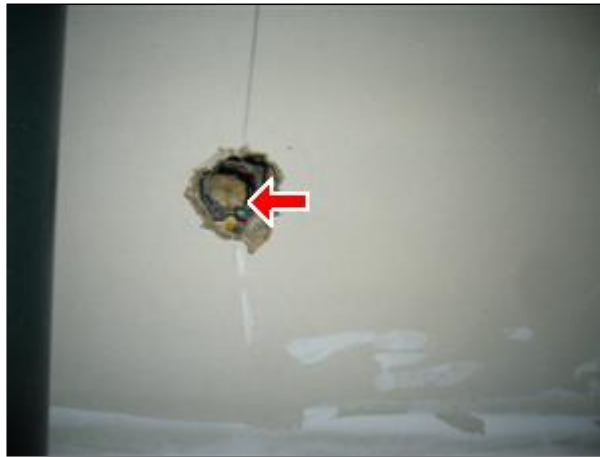
3.1 Picture 1 Hole next to water heater

Comments:
 Hole in the drywall to the left of the water heater needs to be repaired.(Picture 1)

Hole in the drywall to the left of the water heater needs to be repaired.(Picture 1)

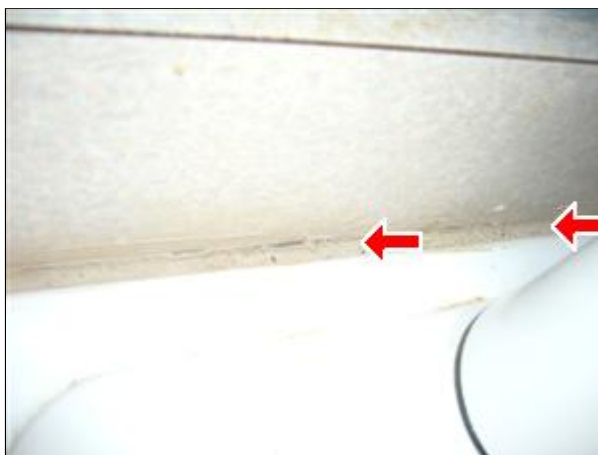
Laminated countertop needs caulking with silicone along backsplash. This is a cosmetic issue for your information. Recommend repair or replace as necessary.(Picture 1)(Picture 2)(Picture 3)(Picture 4)

4.6 Picture 1 Gap in caulking

4.6 Picture 2 Behind sink

4.6 Picture 3 Right side of stove

4.6 Picture 4 Caulking at sink

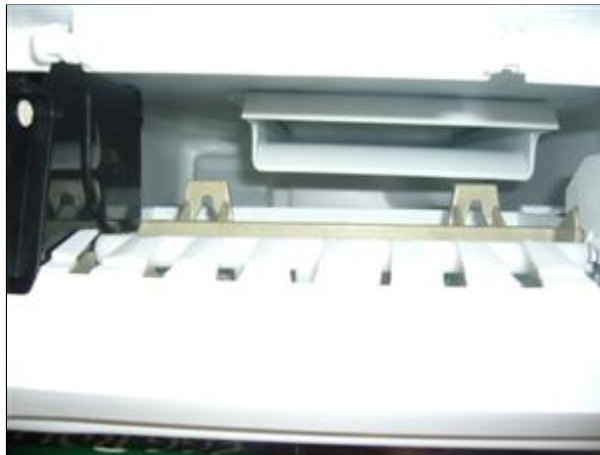
4.15 Picture 1 Ice maker

Ice maker was not working at time of inspection, suggest repair.(Picture 1)

Ice maker was not working at time of inspection, suggest repair.(Picture 1)

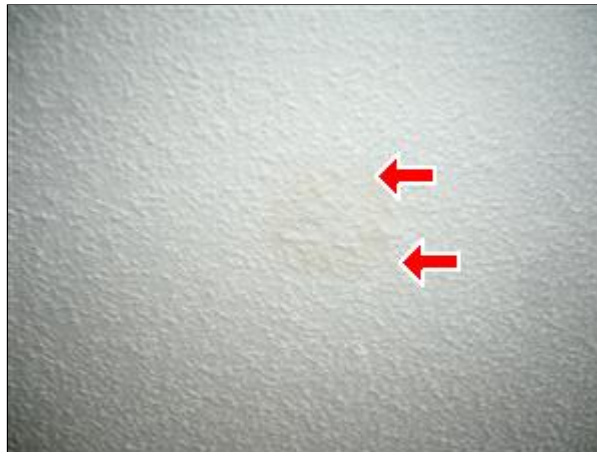
5.0.D Picture 1 Repaired spot

Repair to ceiling in den looks to be caused from the master bathroom shower, moister readings were normal and the drain in the shower has been resealed.(Picture 1)

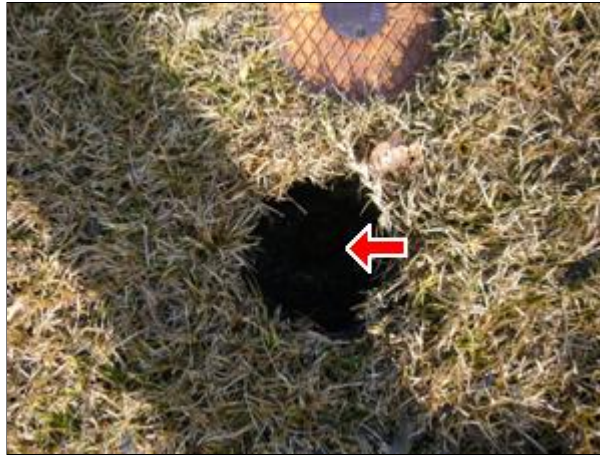
8.3 Picture 1 Main water shut off valve

Water shut off is located to the left of the water heater and in the front yard in front of the meter (left side of driveway).(Picture 1)(Picture 2)

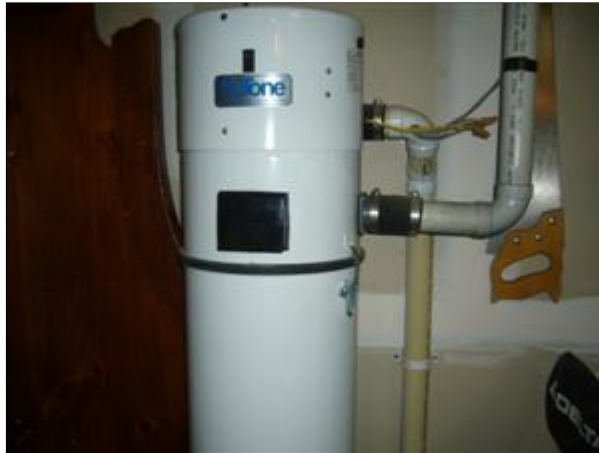
9.10 Picture 1 Vacuum system

Satisfactory(Picture 1) Vacuum system located in garage.

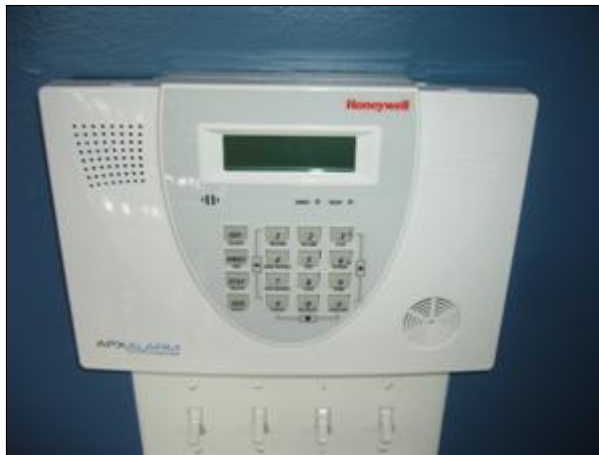
9.11 Picture 1 Security system

Comments:
System was not working at time of inspection.(Picture 1)

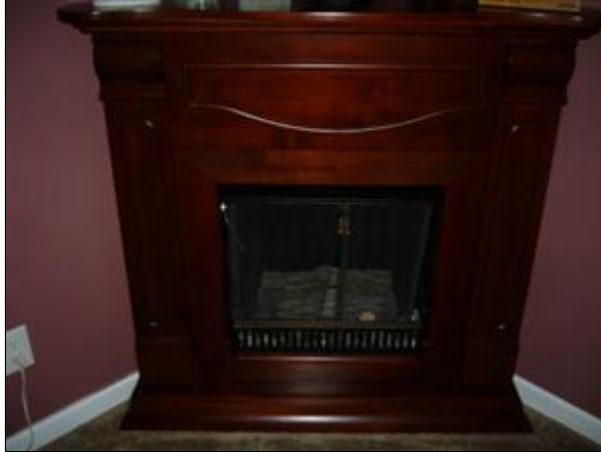
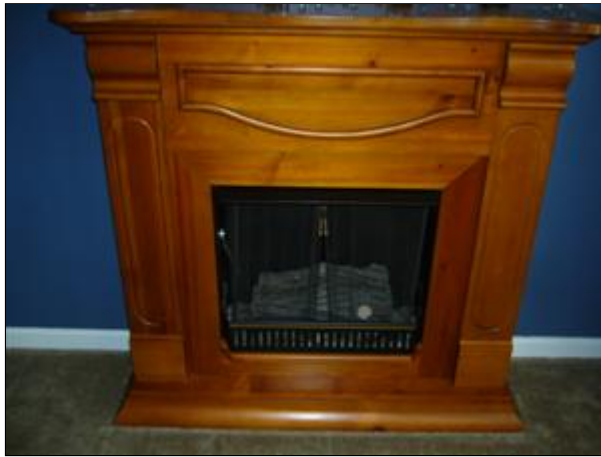
Both fireplaces use gel fuel and can be converted to electric very easily.(Picture 1)(Picture 2)

10.5 Picture 1 Corner unit

10.5 Picture 2 Flat wall unit
