Inspection Report

Property Address:
1234 Somewere St.
Myrtle Beach SC 29588

CHI: Cornerstone Home Inspections of SC, LLC

Date: 1/8/2010	Time: 09:00 AM	Report ID: 0001
Property: 1234 Somewere St. Myrtle Beach SC 29588	Customer: John Sample	Real Estate Professional:

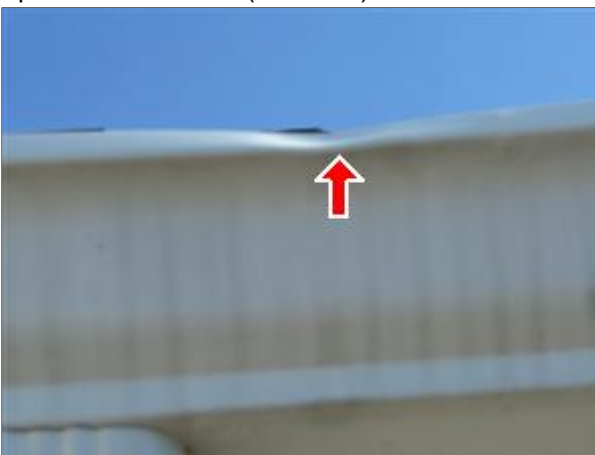
1.4 Picture 1 Left side gutter

One small dent in the gutter on the left side of the screened in porch, this purely cosmetic and does not impede the structure or the operation of the unit.(Picture 1)

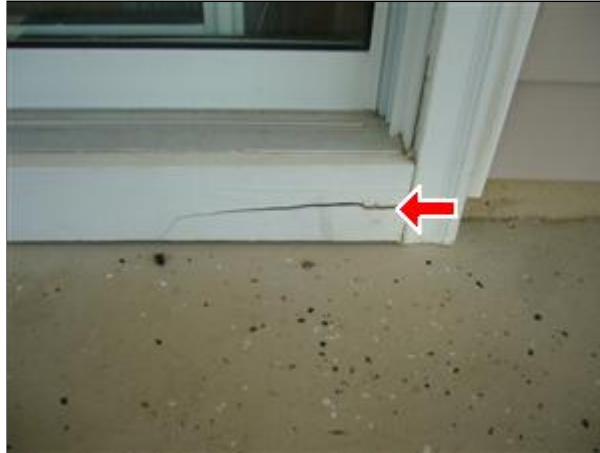
2.1 Picture 1 Kick plate for back door

Kick plate for sliding door is cracked and loose and should be replaced and secured.(Picture 1)

Kick plate for sliding door is cracked and loose and should be replaced and secured.(Picture 1)

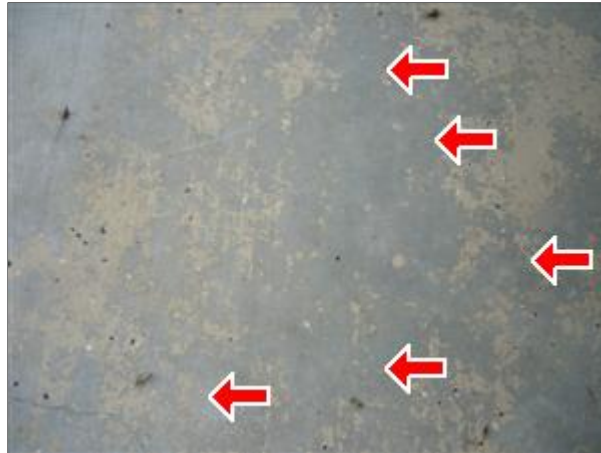
2.3 Picture 1 Worn paint on porch

Paint on back porch and patio is peeling and needs to be redone, suggest using an acid wash and an outdoor epoxy paint for high traffic areas.(Picture 1)

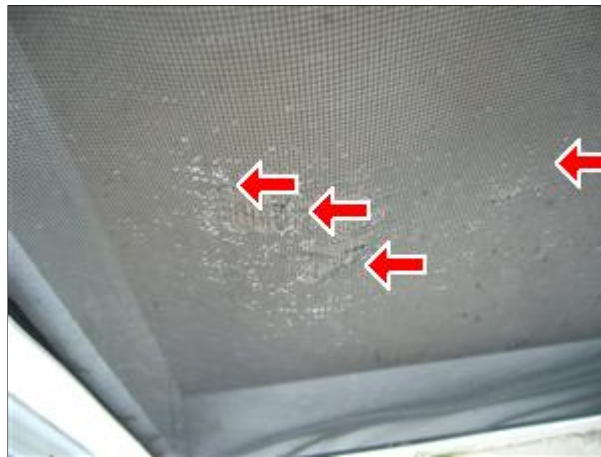
2.3 Picture 2 Holes in screen

Screen to the left of the door needs to be replaced.(Picture 2)

Screen to the left of the door needs to be replaced.(Picture 2)

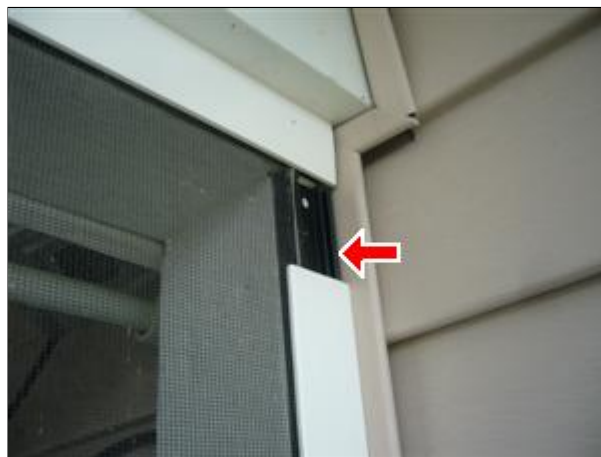
2.3 Picture 3 Screen strap

Screen strap on the upper right corner next to the door needs to be reset to fill gap, easy fix.(Picture 3)

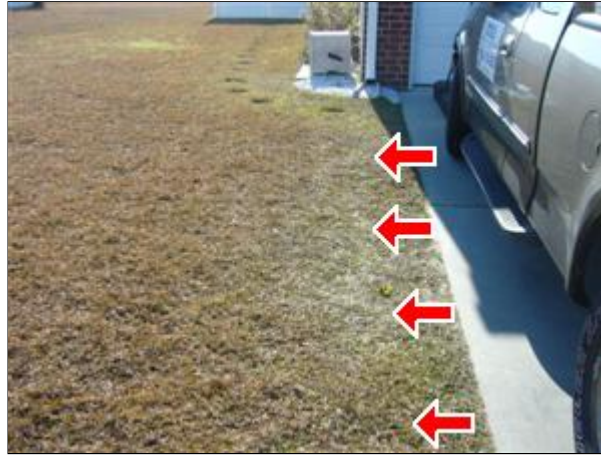
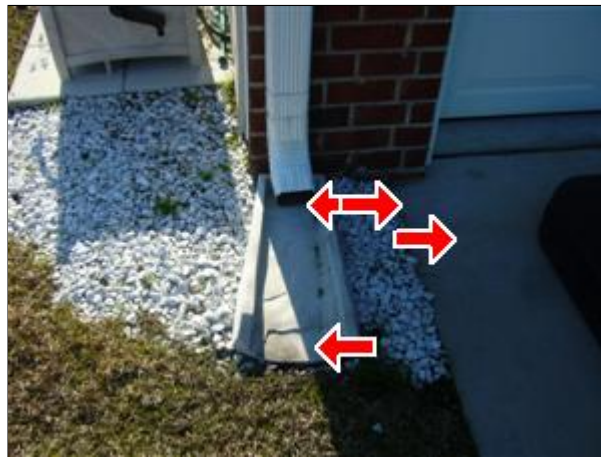
2.4 Picture 1 Saturated grass area

Grass on the left side of driveway is saturated and shows signs of damage, suggest adding an extension on the downspout to re-direct the water to drain down the driveway instead of grass.(Picture 1)(Picture 2)

Grass on the left side of driveway is saturated and shows signs of damage, suggest adding an extension on the downspout to re-direct the water to drain down the driveway instead of grass.(Picture 1)(Picture 2)

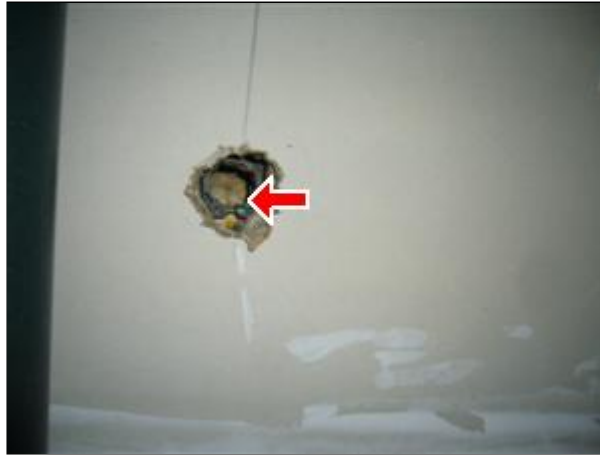
3.1 Picture 1 Hole next to water heater

Comments:
 Hole in the drywall to the left of the water heater needs to be repaired.(Picture 1)

Hole in the drywall to the left of the water heater needs to be repaired.(Picture 1)

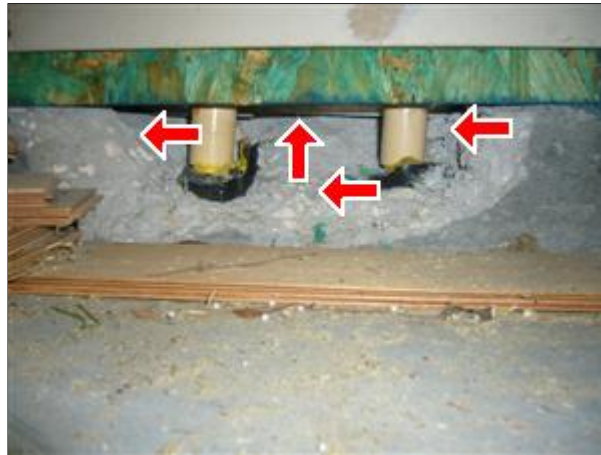
3.2 Picture 1 Exposed water pipes

Exposed water pipes behind water heater need to be packed with insulation and cement repaired and sealed.(Picture 1)

Exposed water pipes behind water heater need to be packed with insulation and cement repaired and sealed.(Picture 1)

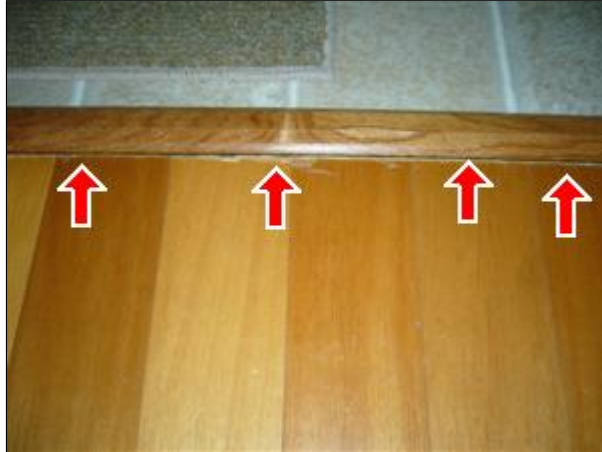
4.3 Picture 1 Threshold at laundry door

Threshold for laundry door needs to be reset to cover gap, easy fix with good glue.(Picture 1)

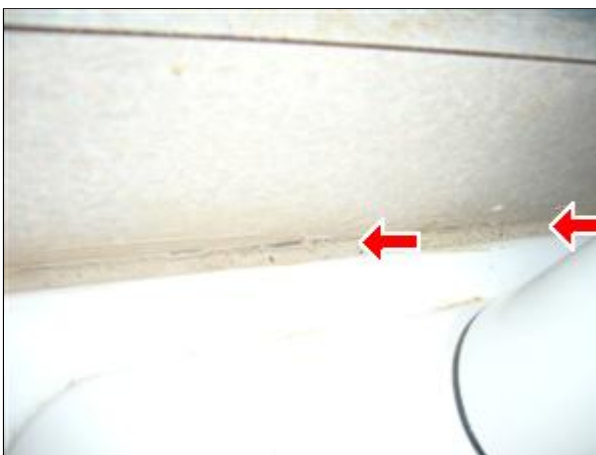
4.6 Picture 1 Gap in caulking

Laminated countertop needs caulking with silicone along backsplash. This is a cosmetic issue for your information. Recommend repair or replace as necessary.(Picture 1)(Picture 2)(Picture 3)(Picture 4)

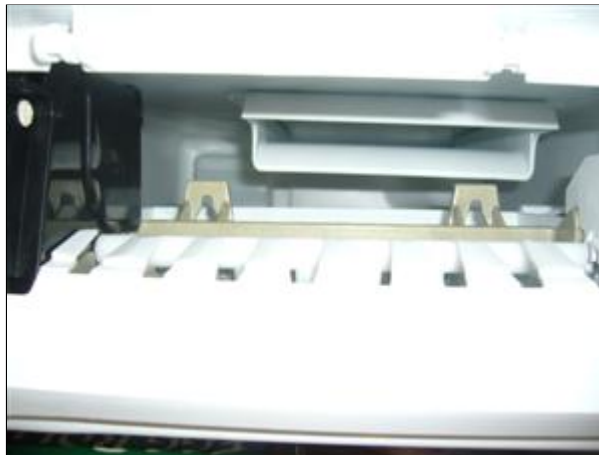
4.15 Picture 1 Ice maker

Ice maker was not working at time of inspection, suggest repair.(Picture 1)

Ice maker was not working at time of inspection, suggest repair.(Picture 1)

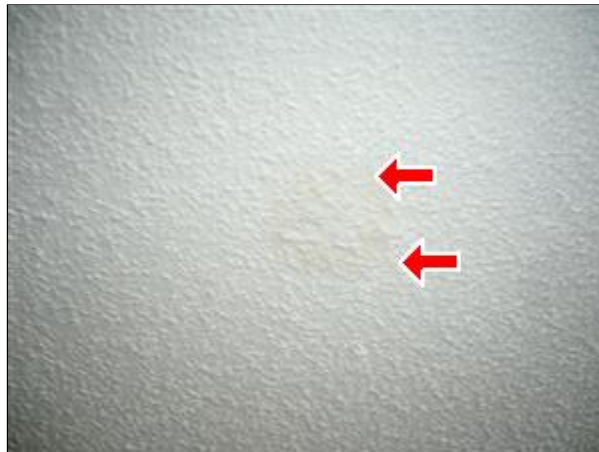
5.0.D Picture 1 Repaired spot

Repair to ceiling in den looks to be caused from the master bathroom shower, moister readings were normal and the drain in the shower has been resealed.(Picture 1)

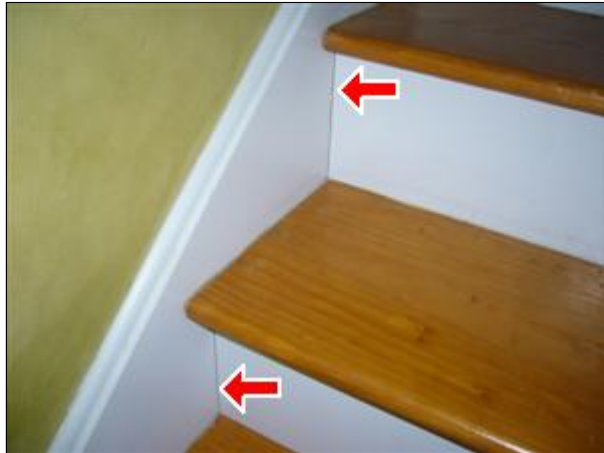
5.3.D Picture 1 Gaps in caulking

Stairs need to be caulked on both side in several areas.(Picture 1) Also carpet is frayed at the bottom corner of the top riser. This is a cosmetic issue for your information.(Picture 2)

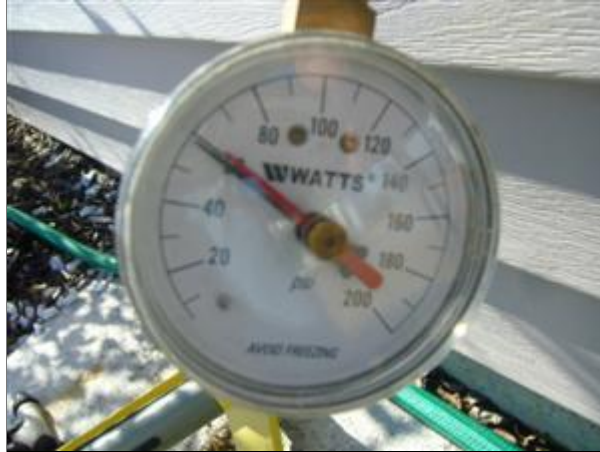
8.4 Picture 1 Water pressure test

The water pressure was steady at 60 psi which is normal and safe.(Picture 1)

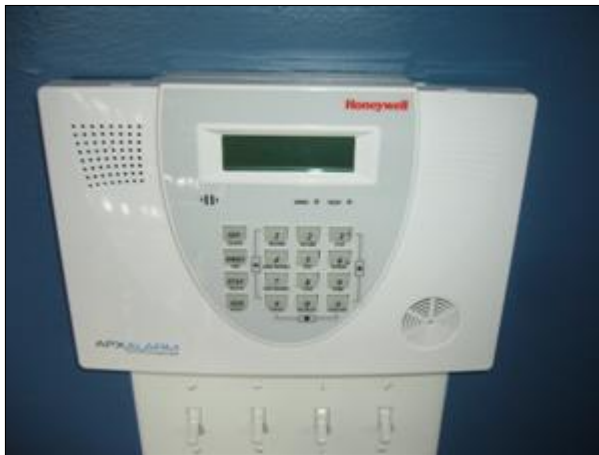
9.11 Picture 1 Security system

Comments:
System was not working at time of inspection.(Picture 1)
